Manhole Inspection Summary

Manhole # S3900_004MH

Location Address: **2230 CECIL AVE** Cross Street: **BARTLETT AVE**

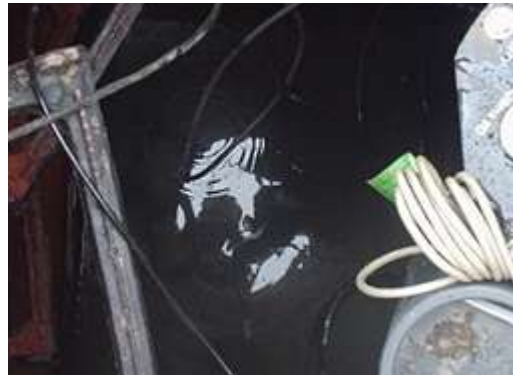
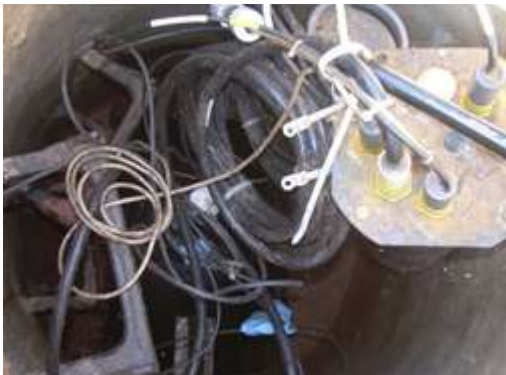
Comments **ADS FLOW MONITOR INSIDE MH - Unable to get a good Top View picture.**

Flow meter. Bench debris.

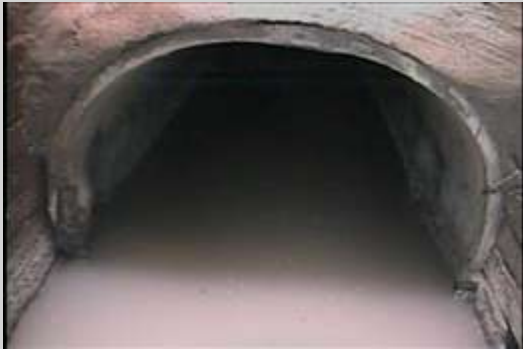
28 in. (w) x 42 in. (h) Unknown Gravity Sewer
Pipe Out @ 12 O'Clock

Infiltration: **Evidence** Pipe Seal Cond: **Unknown**
